**CHESSMAN DAM REHABILITATION INVESTIGATION**

**SUPPLEMENTAL REPORT**

**GEOTECHNICAL AND PRELIMINARY  
ENGINEERING**

**DECEMBER 1985**

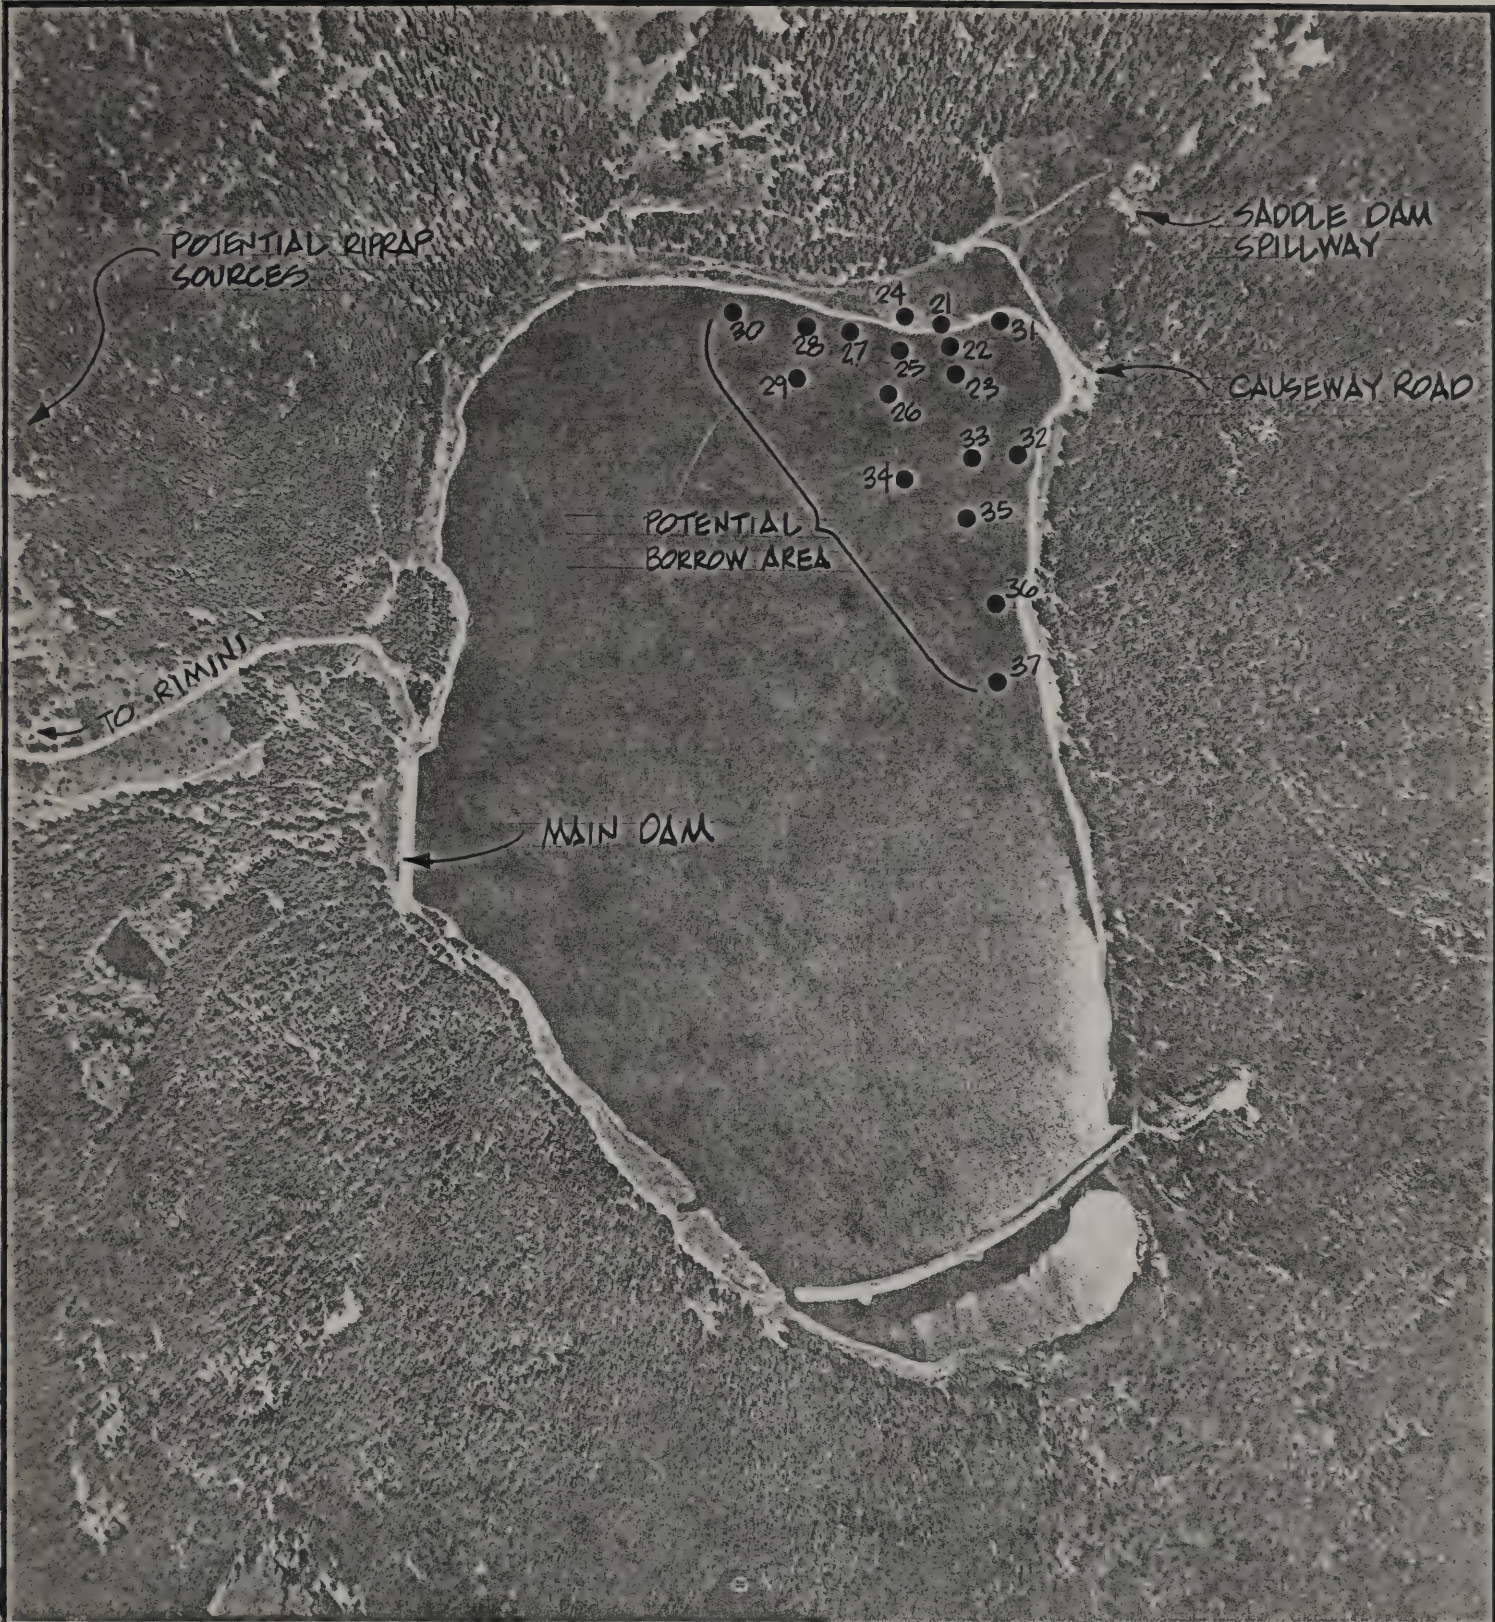
**CHESSMAN DAM**  
**REHABILITATION INVESTIGATION**  
**TEST PITS - BORROW**  
**AND RIPRAP SOURCES**  
**FIGURE 3**

Water was encountered in many of the test pits. The in-place moisture content of the sand is above optimum moisture and unless the reservoir level is drawn down further, it will probably be necessary to dry the borrow in order to place and compact it.

The existing riprap on the upstream slope of the dam is in good condition and appears to have performed well. It consists of near cubical shaped blocks and was placed by hand to achieve a smooth face. The existing riprap can be removed and reused.
